Manhole Inspection Summary

Manhole # S43K2_002MH

Insp Date: **4/29/08 9:32 AM**

Location Address: **1014 Church St.**

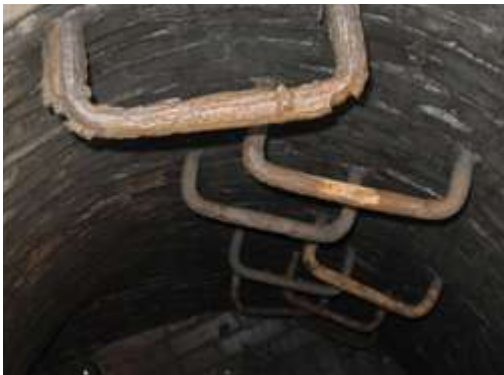
Steps

Count: **8** Missing: **0** ☒ **Corroded**

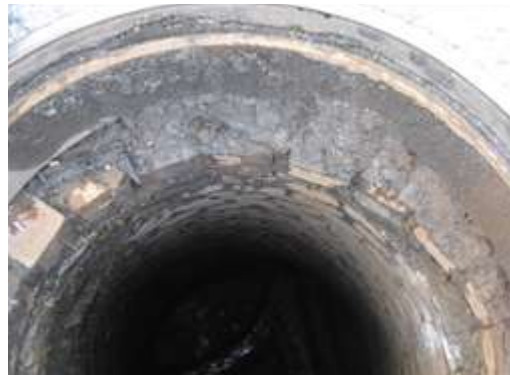
Defect 1

30" cover is placed over 24" Chimney

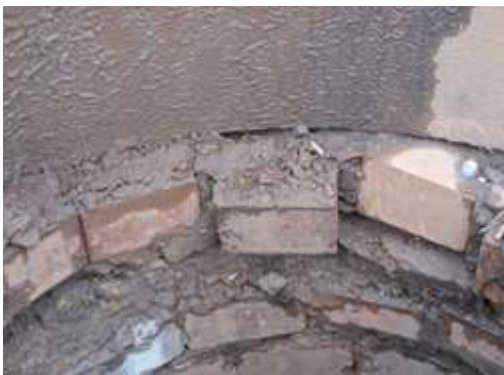
Defect 2

Condition: ☐ Sound ☒ **Cracked** ☐ Root Intrusion ☐ Loose Brick ☐ Deteriorated

Infiltration: ☐ None ☒ **Joint** ☐ Cracks ☒ **Mortar** ☐ Roots ☒ **Wall**

Deteriorated Chimney

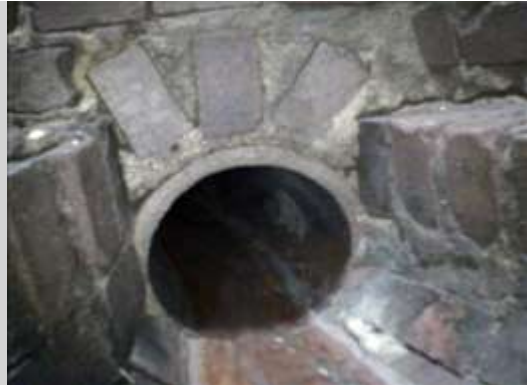
12 O'Clock Outflow

8 in. Circular Gravity Sewer
Pipe Out @ 12 O'Clock

Pipe Height: **8.4** (in.) Rod and Bar (Angled)
Pipe Material: **Clay** ☐ Pipe Lined
Invert Depth: **14.14** (ft.) Flow Characteristics: **Fast**
Deposits: ☒ None ☐ Mud ☐ Sludge ☐ Debris ☐ Grease
Silt Depth: (in.) Deposits Extent:
Infiltration: **None** Pipe Seal Cond: **Sound**

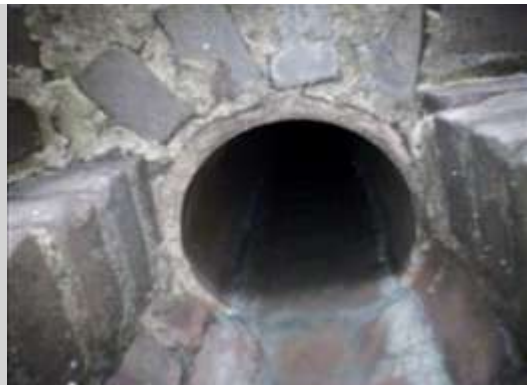
6 O'Clock Inflow

8 in. Circular Gravity Sewer
Pipe In @ 6 O'Clock

Pipe Height: **8.4** (in.) Rod and Bar (Angled)
Pipe Material: **Clay** ☐ Pipe Lined
Invert Depth: **13.74** (ft.) Flow Characteristics: **Fast**
Deposits: ☒ None ☐ Mud ☐ Sludge ☐ Debris ☐ Grease
Silt Depth: (in.) Deposits Extent:
Infiltration: **None** Pipe Seal Cond: **Sound**

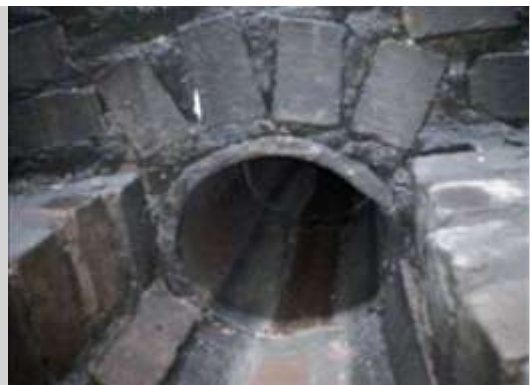
9 O'Clock Inflow

8 in. Circular Gravity Sewer

Pipe In @ 9 O'Clock

Infiltration: **None** Pipe Seal Cond: **Cracked**
